# Good Earth Tools (GET) Tungsten Carbide Solution Outperforms OEM Steel Cleats by Nearly 400% at Recycling Facility.

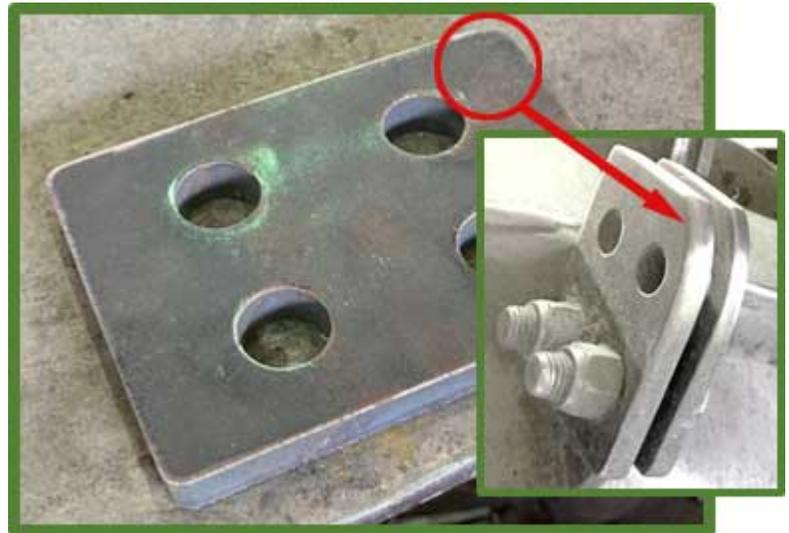
A new steel OEM cleat and an old steel OEM cleat showing extreme rounding of corners after only 3 months of abrasion and impact.

A leading materials recycling facility (MRF) was seeing extreme wear on equipment at the very beginning of the company's materials separation process. The facility uses a feeder drum to provide a continuous flow of materials onto conveyors to sort materials. On the feeder drum there are 24 steel cleats that grab materials and pull them into the system. From normal operation, the edges of the OEM steel cleats wore down and became rounded in a matter of weeks. The rounded cleats worked less efficiently, leading to jams at the intake point and downtime to clear the material. Because of this accelerated wear, the cleats needed to be changed every three months, resulting in eight hours of downtime, loss of production, and an increased safety risk for each change-out.

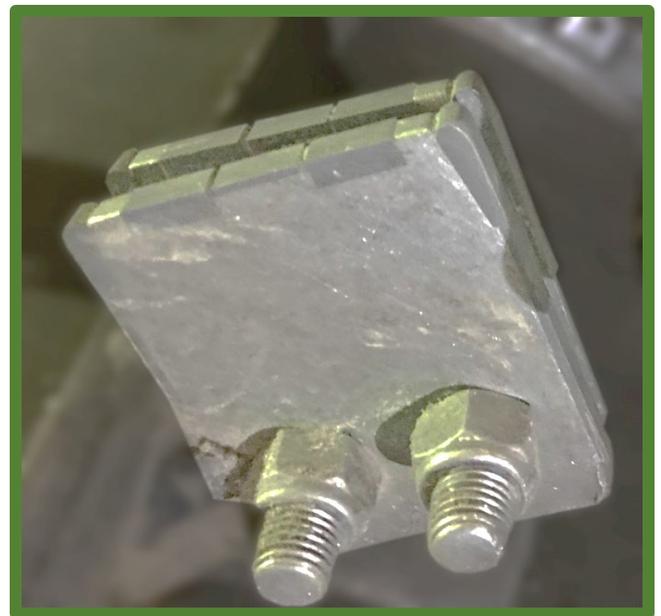
GET Tungsten Carbide Cleat showing no signs of wear after 14 months.

The original GET Tungsten Carbide Cleats have lasted 14 months with no rounding and are still going strong! This improvement is 4 times greater than the OEM steel cleat. The Maintenance Manager at this facility was so pleased with the results that he endorsed the Tungsten Carbide Cleats for a companywide rollout to all facilities across the United States. Another satisfied GET customer has one less maintenance issue, one less safety concern, can focus on other important tasks, and is experiencing 23% maintenance cost savings by making the right decision to partner with GET to implement Tungsten Carbide Cleats.
